Case Study: Continuous Geared Hinges

Intastop Ltd

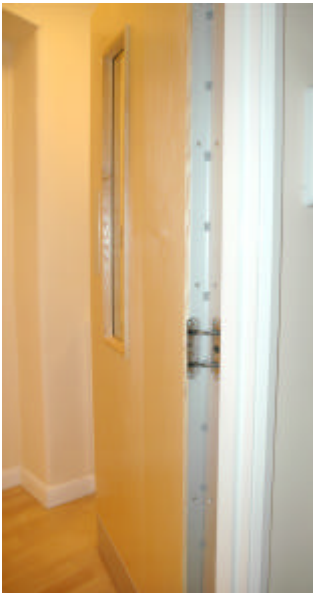
With traditional knuckle hinges weight and stress is concentrated in three locations causing downward weight overload of the bottom hinge and pulling away of the top hinge, damaging the floor and frame components.

With the Intastop continuous geared hinge, weight and stress is dissipated down the entire hinge and evenly "absorbed" throughout the whole door and frame length.

Unlike conventional continuous hinges, the Intastop hinge is a pinless assembly, so there are no pins to wear out.
